FMC – MIDDLEPORT FACILITY

RCRA FACILITY ENVIRONMENTAL INVESTIGATION

AIR DEPOSITION AREA 1 & CULVERT 105 SOILS

AGENCIES' JUNE 2009

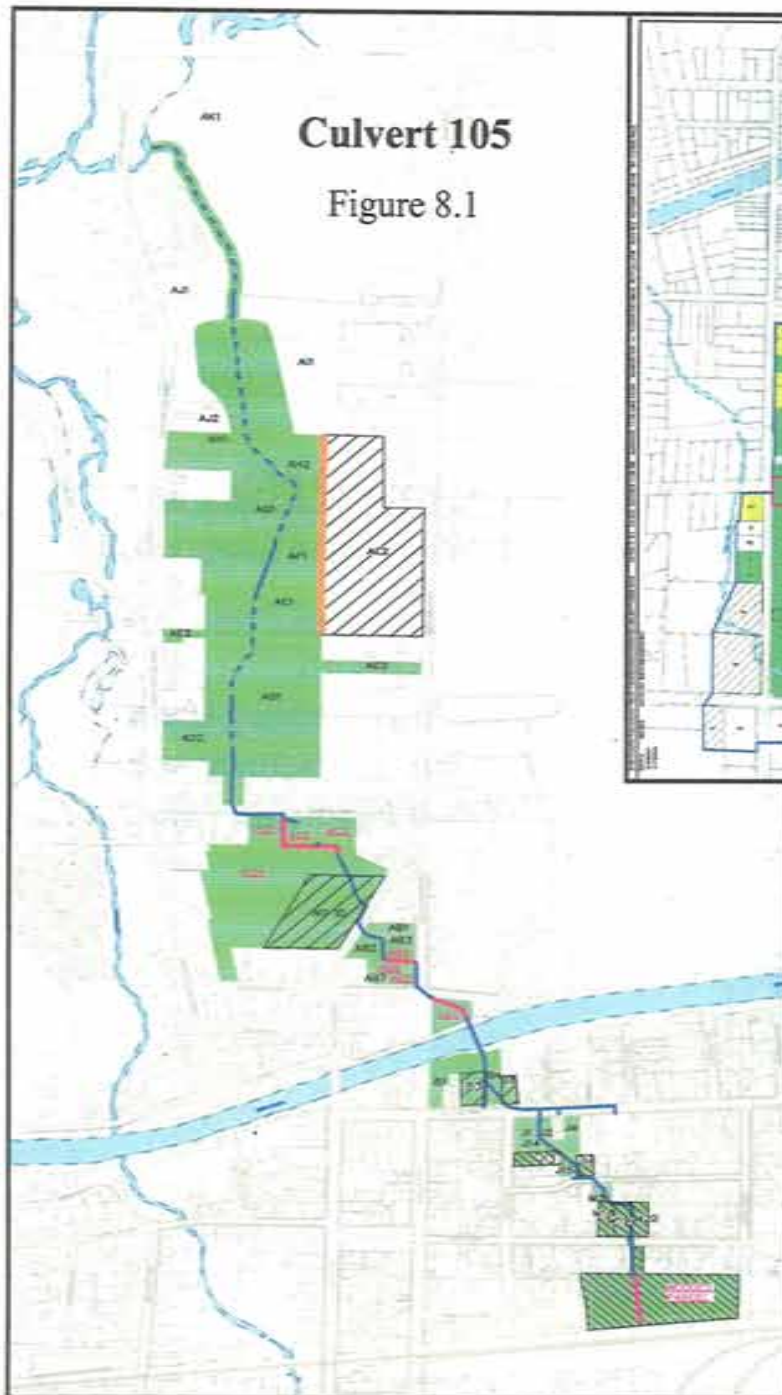
- Culvert 105 (Figure 8.1):
 - Blue/Violet Line: Culvert Pipe/Ditch
 - Green Area: Approximate Extent of Affected Properties/Areas

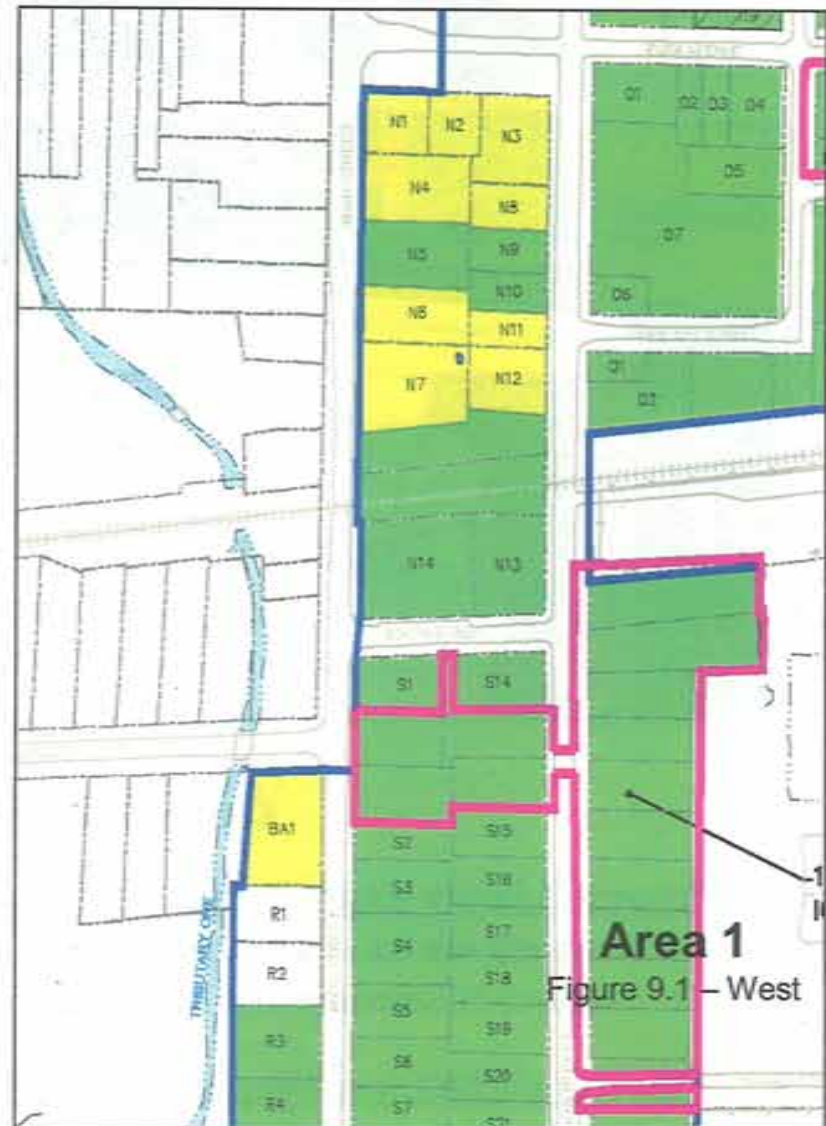
- Green Properties (Affected):
 - Elevated Arsenic in Soil (> 20 ppm)
 - Arsenic Consider FMC-Related
 - Properties Included in FMC CMS
- Yellow Properties (Un-Affected):
 - Generally Background Arsenic Concentrations (Mainly ≤ 20 ppm)
 - Agencies' Determined No Further Action
 - Properties Not Included in FMC CMS
- White Properties, Inside Blue (Un-Affected):
 - Soil Sampling Performed
 - Arsenic Present Either in Background Conc. or Elevated Due to Suspected non-FMC Source
 - Properties Not Included in FMC CMS
- White Properties, Outside Blue (Un-Affected):
 - No Soil Sampling
 - Arsenic Concentrations Unknown
 - Not Considered Affected by FMC
 - Properties Not Included in FMC CMS

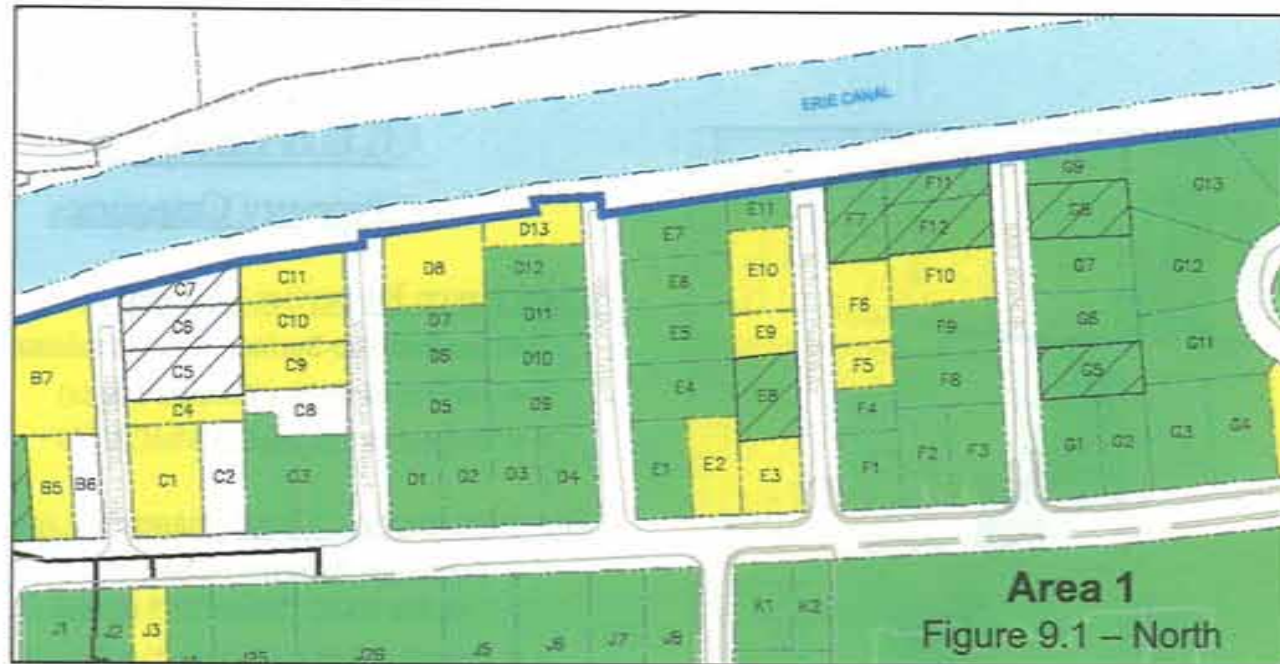
AREA 1 - Property Categories

- Green Properties, Wide Diagonal Lines (Potentially Affected):
 - FMC Property Access Not Obtained – No Soil Sampling Data
 - Adjacent Arsenic Data Suggests Potential Elevated Arsenic Concentrations
 - Properties Included in FMC CMS

- White Properties, Wide Diagonal Lines (Un-Affected):
 - FMC Property Access Not Obtained – No Soil Sampling Data
 - Adjacent Arsenic Data Suggests Background Arsenic Concentrations
 - Properties Not Included in FMC CMS

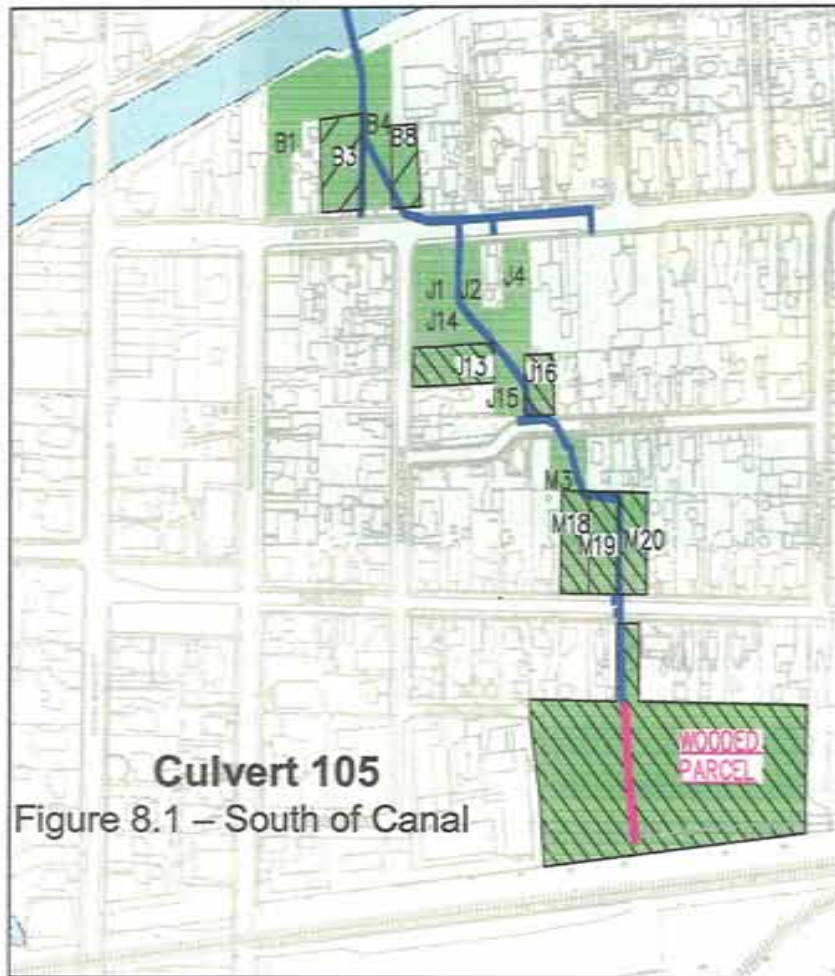
- Plain Green Properties (Affected):
 - Arsenic Sub-Surface Soil Contamination
 - Mainly Near Pipe (Breaks/Leaks)
 - Properties Included in FMC CMS
- Green Properties, Close Diagonal Lines (Affected):
 - Properties Affected by both FMC Air Deposition and/or FMC Culvert 105 Releases
 - Potential Surface Soil and/or Sub-Surface Soil (Near Pipe) Contamination
- Green Properties, Wide Diagonal Lines (Potentially Affected):
 - FMC Property Access Not Obtained – No Soil Sampling Data
 - Potential Arsenic Sub-Surface Soil (Near Pipe) Contamination
 - Properties Included in FMC CMS
